**DEPARTMENT OF TRANSPORTATION**

Contract #: 04-0120F4Cty: SF/ALA Rte: 80 PM: 13.2/13.9File #: 69.28**WELDING INSPECTION REPORT****Resident Engineer:**Pursell, Gary**Address:** 333 Burma Road**City:** Oakland, CA 94607**Report No:** WIR-015129**Date Inspected:** 26-Jun-2010**Project Name:** SAS Superstructure**OSM Arrival Time:** 700**Prime Contractor:** American Bridge/Fluor Enterprises, a JV**OSM Departure Time:** 1900**Contractor:** Zhenhua Port Machinery Company, Ltd (ZPMC), Changxing Island **Location:** Shanghai, China**CWI Name:** Li Yang and Wu Zhi Cheng**CWI Present:** Yes No**Inspected CWI report:** Yes No N/A**Rod Oven in Use:** Yes No N/A**Electrode to specification:** Yes No N/A**Weld Procedures Followed:** Yes No N/A**Qualified Welders:** Yes No N/A**Verified Joint Fit-up:** Yes No N/A**Approved Drawings:** Yes No N/A**Approved WPS:** Yes No N/A**Delayed / Cancelled:** Yes No N/A**Bridge No:** 34-0006**Component:** OBG Trial Assembly**Summary of Items Observed:**

Orthotropic Box Girder (OBG) Trial Assembly Areas

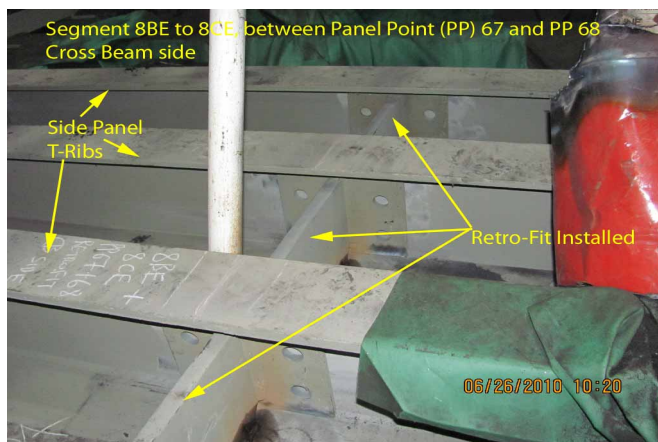
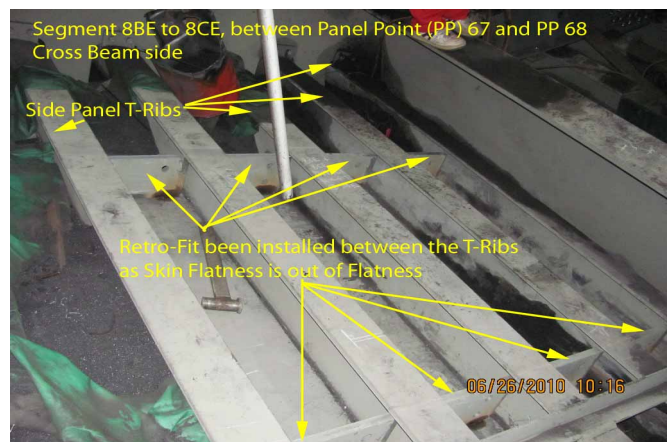
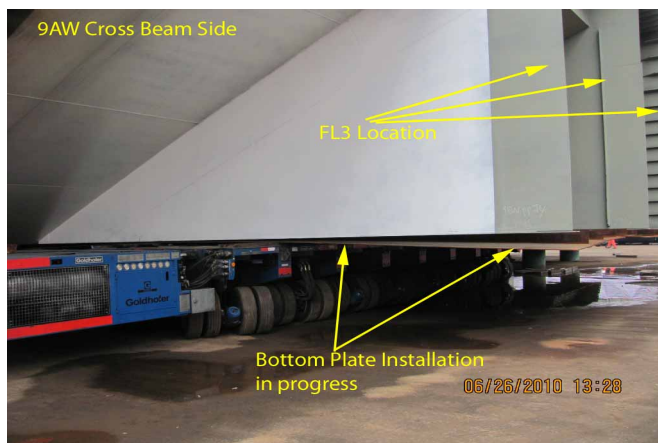
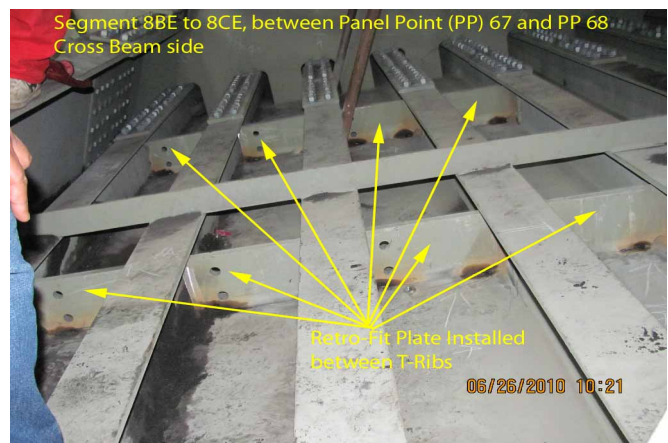
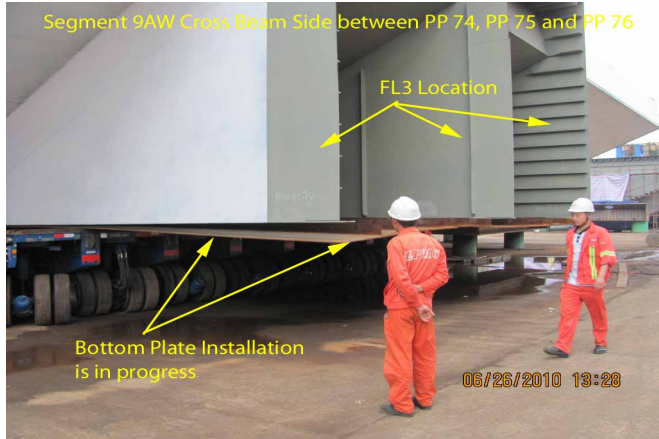
This QA Inspector observed Bottom Plate installation is in progress at the FL3 location for Segment 9AW between Panel Point (PP) 74, PP 75 and PP 76. Please refer the pictures attached below for more comprehensive details.

This QA Inspector observed during random visual Inspection that ZPMC personnel Installing the Retro-fit plates between the Side Panel T-Ribs for the Segment 8BE to 8CE between Panel Point 67 and PP 68 Cross Beam Side. The Installation of the Retro-fit is been performed against the ZPMC Doc. No. GGL-MQ-1666. The Retro-fit is Installed as the Skin Flatness at location recorded at B1=1 0mm, B1-1=6mm and B2=6mm.

This QA Inspector observed during random visual Inspection that ZPMC personnel Installing the Retro-fit plates between the Side Panel T-Ribs for the Segment 8AE to 8BE between Panel Point 64 and PP 65 Cross Beam Side. The Installation of the Retro-fit is been performed against the ZPMC Doc. No. GGL-MQ-1666. The Retro-fit is Installed as the Skin Flatness at location recorded at B1=6mm and B2=9mm.
